CONSIDERATIONS ON THE ACID MINE DRAINAGE DISCHARGES IN NATURAL RECEPTORS, FROM THE BAIJA-MARE FORMER MINING AREA

This paper presents the situation of five mines in Baia-Mare area, Maramureș County (Câmpurele, Tyuzoșa, Ilba Handal – near Băița village, the gallery in the central area of Cavnic and Reiner gallery from the same town) as it is in 2013, both in terms of water treatment applied methods after the evacuation from the mine galleries, and the parameters values of water samples from these five mines.

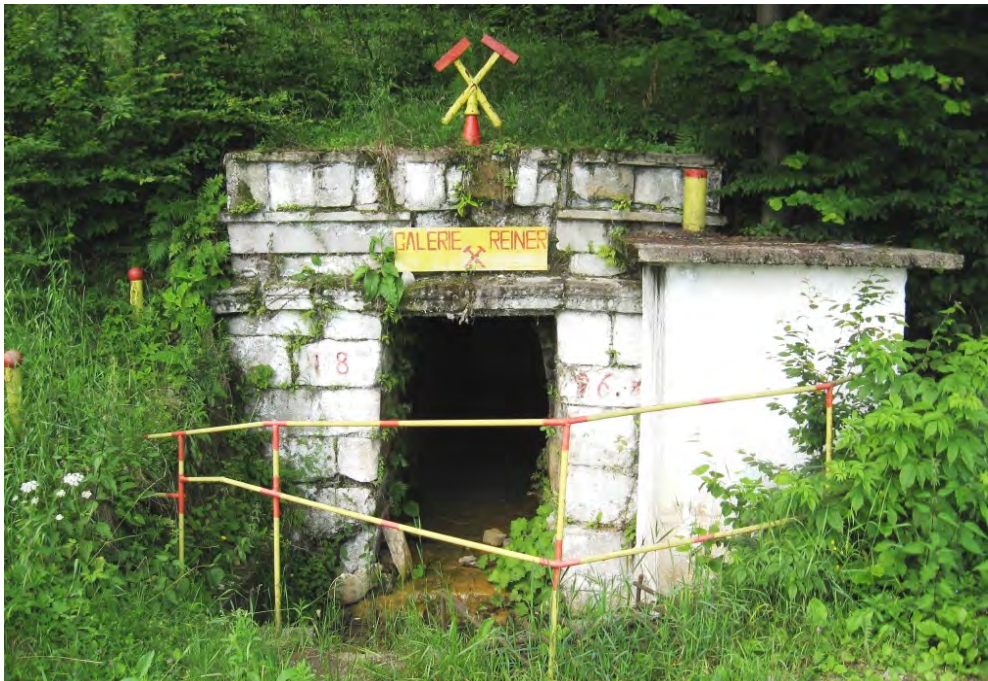
Fig. 1. *Reiner Gallery (Cavnic)* (<http://www.mindat.org>).

- *Cavnic - Reiner Gallery* – a plating with limestone for pH neutralising and a filtering material layer for metal ions and sulphate precipitation has been used for the greening process of this gallery; the quality of the filtered water suffers a major improvement and it can be discharged in a natural receptor without affecting its quality (Fig.1).

The results obtained show that the limestone plating water treatment method applied at Reiner Gallery is very effective, as the metal ions concentrations are reduced, most of them falling below the maximum allowed level for wastewater discharging in a natural receptor regulated by the Romanian law. Out of the nine studied metals, only the Mn and Zn concentrations are above the maximum level regulated by law. Also, the pH is the closest to the neutral value (pH = 6). A high electrical conductivity is also noted (491 µS/cm), which means that there is a significant amount of dissolved salts, probably derived from the adsorption process of metal ions on the filtering material from the greening system of the mine.

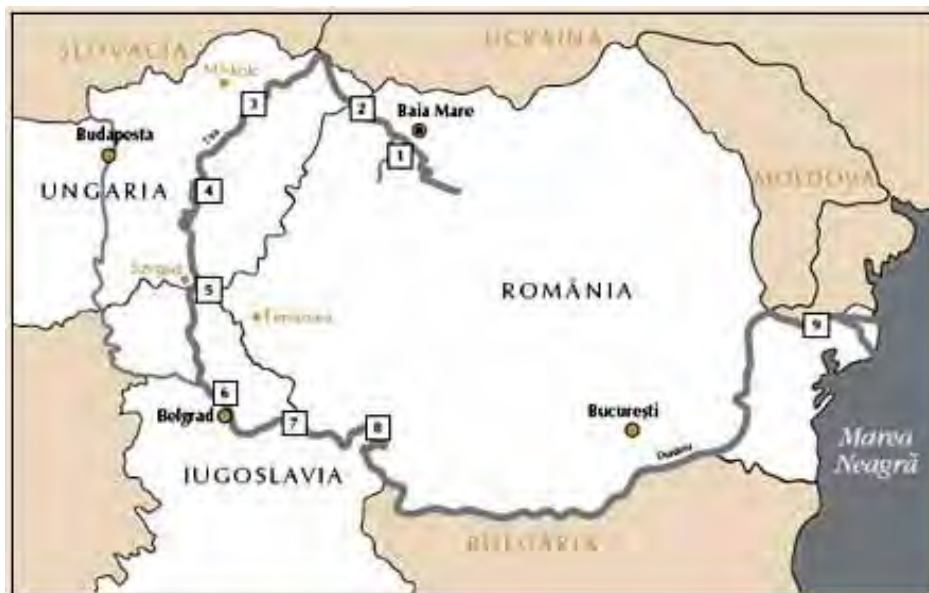
Fig. 2. The course of toxic substances from the Aurul Bozânta Mare tailing pond, Maramureș County (1 - cyanide discharge from the tailing pond; 2 - cyanide wave reaches the Romanian - Hungarian border; 3 - Tiszaok, Hungary; 4 - Szolnok, Hungary; 5 - Hungarian - Yugoslavian border; 6 - Beograd (Perlez), Yugoslavia; 7 - Drobeta Turnu-Severin, Romania; 8 - Porțile de Fier, Romania; 9 - Danube Delta, Romania) (UNEP).

In the past 15 years, in the Maramureș mining area there have been several accidental mine water discharges that affected important areas of land by pollution of the water and the soil in the area. The most serious case was at Bozânta Mare on the 30th of January 2000, which had transboundary impact, alerting the authorities in Romania, Hungary and Yugoslavia. The negative impacts were major, the toxic discharges affecting rivers like Săsar, Lăpuș, Someș, Tisa, Danube and finally reaching the Black Sea (Fig.2) (UNEP).

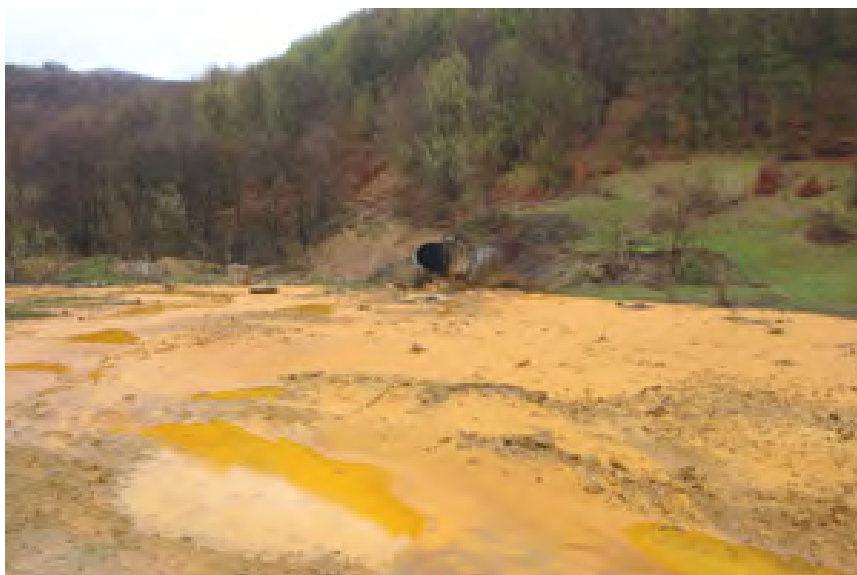
Fig. 3. *Accidental discharge at Purcăreț mine, Ilba* (www.ziarmm.ro)

- August 2010 - Purcăreț gallery, Ilba area – caused by the underground cavings and water and mud accumulations which have exceeded the capacity of the evacuation system (Fig.3) (www.informatia-zilei.ro);
- April 2013 - Câmpurele gallery - accidental discharge of acid mine drainage due to water accumulation in the underground caused by the collapsing of a few galleries. The mine water discharged in the Valea Roșie River Valley, then in its emissary - Băița river until it reached the confluence with the Lăpuș River (www.emaramures.ro).
