VALEA IERII'S RIVERBED DYNAMICS AND THE NECESSITY OF ITS RECONFIGURATION WITH THE AIM OF CREATING AN ECOLOGICAL CORRIDOR

Alexandra CEORNEI^{1*}, Vlad MĂCICĂȘAN¹, Gheorghe ROȘIAN¹

¹Faculty of Environmental Science and Engineering, Babeș-Bolyai University,
Fântânele Street, No. 30, 400294, Cluj-Napoca;

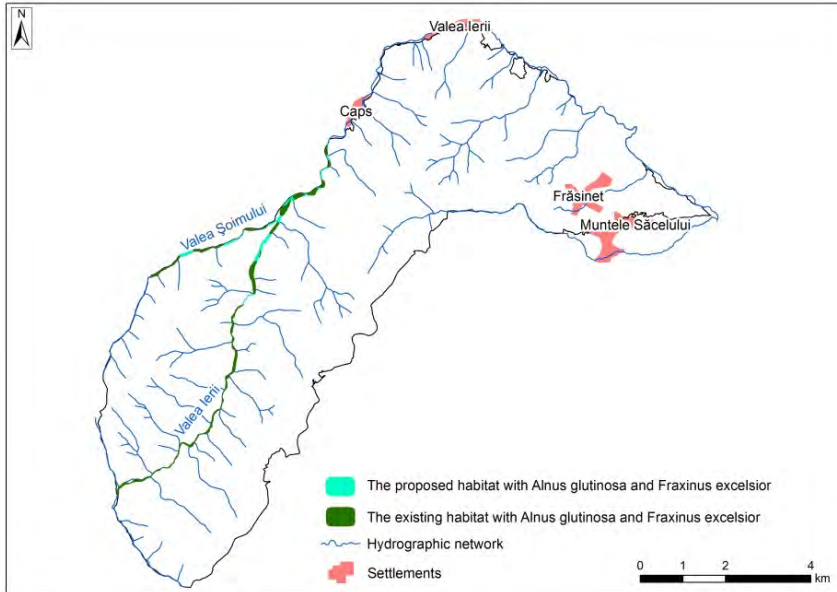
Fig. 2. The reconfiguration potential of alluvial forests habitat with *Alnus glutinosa* and *Fraxinus excelsior*

By using the GIS instruments and the data obtained in the field, we digitized the existing habitat of *Alnus glutinosa* and *Fraxinus excelsior*, and the future possible spatial arrangement of the alluvial forests in the studied area, on a thematic map (figure 2).

In accordance to the final results, we propose the following actions: the removal of the existing invasive species of *Picea abies* in the targeted area and the replanting of *Alnus glutinosa* in the studied sections; the meandering of Valea Ierii river course in order to provide the specific humidity for the vegetal species; the monitoring and periodical checking of the area with the aim of ensuring the protection and the conservation of the above mentioned species.

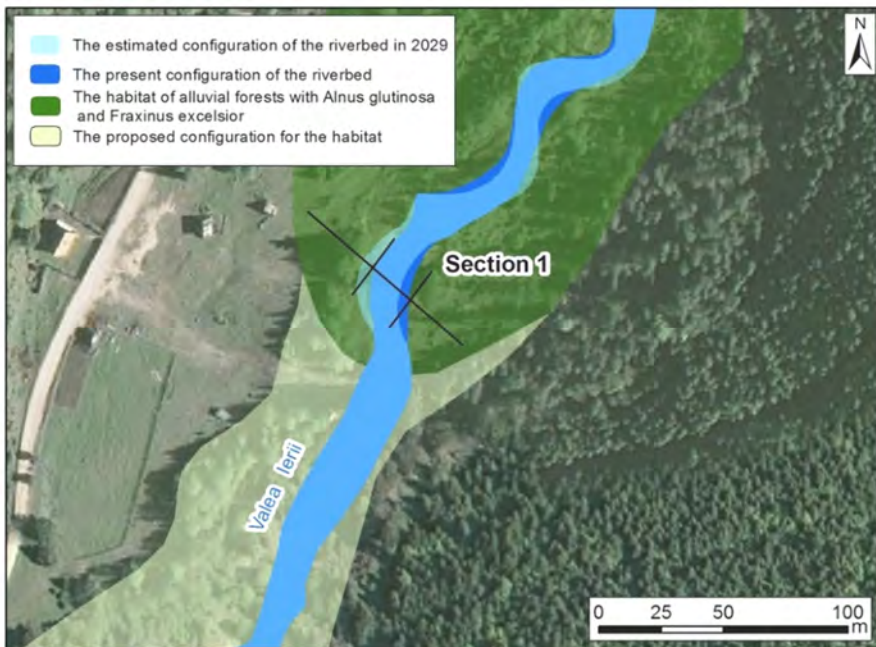
Fig. 3. The simulation of the configuration for Valea Ierii river and alluvial forests habitat in Section 1

The first section is located in the very proximity of the confluence between Valea Ierii and Valea Șoimului rivers. The aggradation of the river bank is not major but it indicates an erosion that evolves over time, both on the concave and convex river banks. Moreover, this section is affected by intense deforestation and wood processing activities.

After analysing the obtained data, we performed a simulation of the future configuration for each studied section of the river bed with its corresponding targeted habitat. By extrapolating the level of meandering for other points than the ones chosen in the field, we determined a new structure of the studied area that could have the following aspect in the next 15 years (Fig. 3., Fig. 4., Fig. 5.).

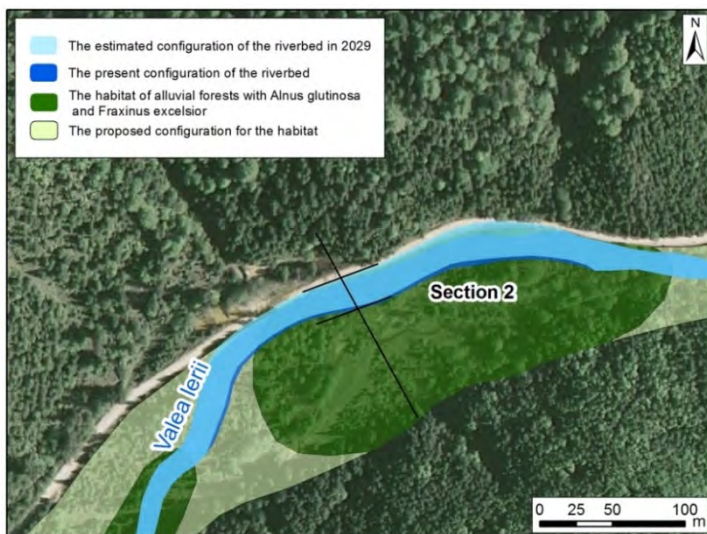
Fig. 4. The simulation of the configuration for Valea Ierii river and alluvial forests habitat in Section 2

The second section is situated in the central sector of Valea Ierii's river course, along a deposition. In the point number V we found the maximum erosion rates from the studied area, where the course of the river divides. After consulting the locals, we discovered that this river sector has modified its course from the base of the forest to the road. This fact can also be observed in the field. As a result, this section presents a higher level of erosion impact which can affect the river meadow area.

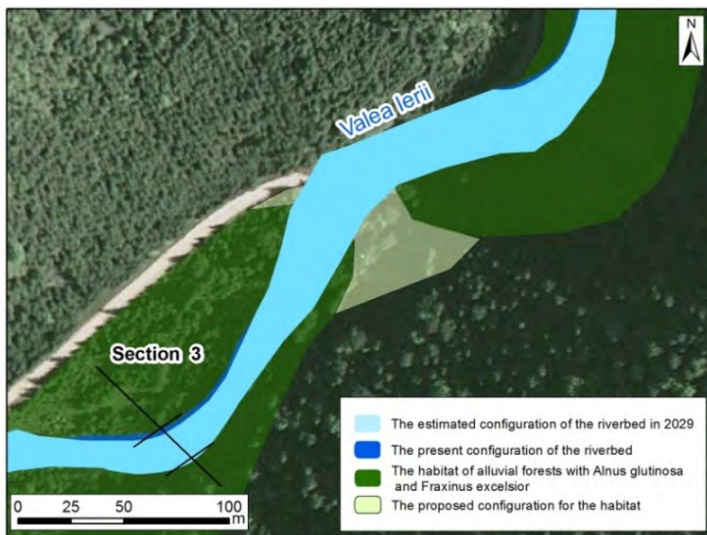
Fig. 5. The simulation of the configuration for Valea Ierii river and alluvial forests habitat in Section 3

The last section can be found in the proximity of Caps village and can be distinguished by a well outlined deposition and by the pronounced river banks resulted from an intense process of erosion. In this area, the retreat of the sediments reached 30 cm, which means that the convex river bank is exposed to downfall processes. In the proximity of the water course there are a series of saplings planted for fixing the surface, but the floods affect all the vegetation.
