## **ANALYZE OF THE PHYSICAL-CHEMICAL PROPERTIES OF THE SOIL IN THE AREA POSTA RAT / TURDA**

**ABSTRACT.** The most important contaminated areas from Cluj County are the uncontrolled HCH scrap deposits from Turda city, which appeared as a result of the industrial activity of the former Chemical Plant Turda. Over the years, were identified 4 locations in the area. The four contaminated locations situated in the area of Turda city Sum up to 60000 tons of HCH polluted soil are. One of these zones is the Posta Rat area (40000 m<sup>2</sup>) which is situated on the left bank of Aries River. The objective of this paper is to carry out experimental researches in order to establish the physical-chemical properties of the soil from Posta Rat area, soil contaminated with HCH (hexachlorocyclohexane). The texture, structure, humidity and pH are the main analysis performed in order to determine the optimum cleaning technologies for the deteriorated soil as a result of the activity of the Chemical Plant in Turda. The results of the physical-chemical analysis can point out the most suitable cleaning soil solution, because as a result of the study, the characteristics of the soil are known, bein

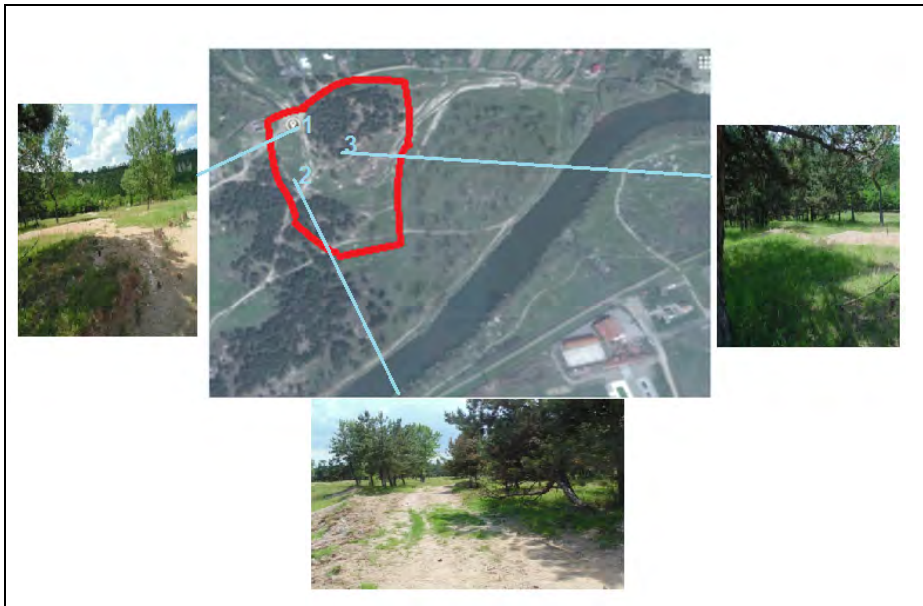
**Fig. 1.** *Sampling points*

From Posta Rat area were taken 3 soil samples (figure 1) from different depths, according with table 1.

**Sampling point 1** is located in the north-west part, towards the limit of the studied area, near a local residence (46,566718N; 23,814856E). In the depth of the soil profile was observed the existence of the same soil type, cement looking, and the presence of HCH could be seen clearly (white-grey color).

**Sampling point 2** is located in the central part of the area towards the south (46,565711N; 23,814951E). Nearby were found coniferous trees among which well delimited zones which were not covered by any type of vegetation. The aspect of the soil from this point is very similar with point 1, cement looking and with visible traces of HCH.

**Sampling point 3** is located in the central area towards east (46,566165N; 23,815801E). In this point the vegetation is much denser, but the traces of HCH are similarly visible.

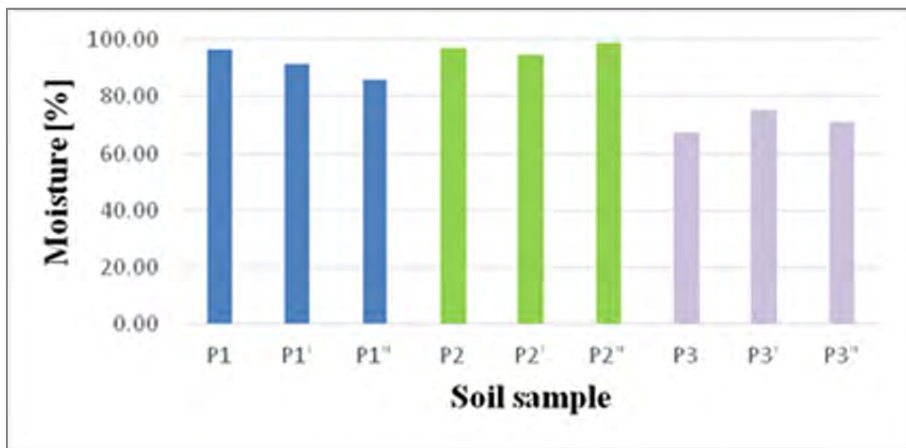
**Fig. 2.** Soil humidity from Poșta Rât area

According with the results obtained (figure 2) it can be seen that the soil from the studied area contains a high quantity of physical bonded water in its mass. This thing is clearly observed due to the fact that the majority of the samples have a humidity percent of over 80 %. Sampling point 3 registered lower values (60 – 80 %).

In order to determine the actual humidity was used the gravimetric method which consisted in weighing with analytic KERN scale 100g of each soil sample. The samples were introduced in Binder FD 53 stove, at 105 °C temperature and maintained up to complete evaporation of the physical bonded water (4 hours).

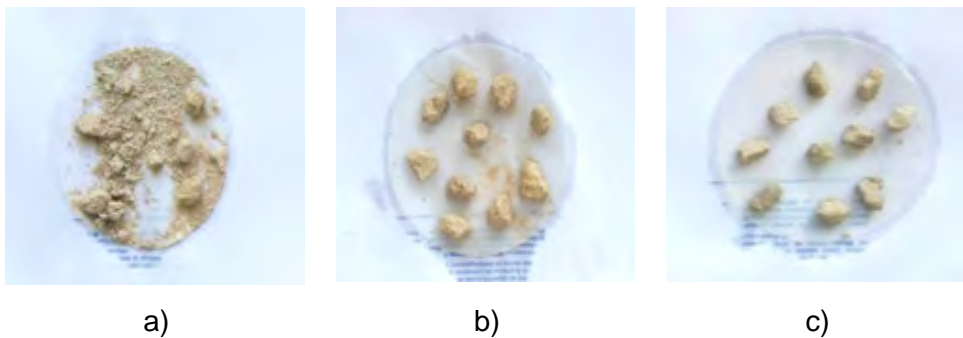
**Fig. 4.** *Structure determination –sampling point 1:*  
a) 0 – 10 cm; b) 30 – 40 cm; c) 60 – 70 cm.

On all three sampling points was noticed the same behavior of the soil in depth plan. The results obtained in the samples of sampling point 1 are shown in figure 4.

Analyzing each sample was observed the variation on depth of the structure type, thus the samples taken from the same depth had the same structure, no matter the sampling point. As a conclusion it can be said that the soil situated at 0 – 10 cm depth is partially structured, the one at 30 – 40 cm is relatively well structured and the soil from 60 – 70 cm depth is very well structured.

From each soil sample were selected 10 soil aggregates with the diameter of about 1 cm. These soil samples were put in a Petri basin/bowl on a filter paper previously moisten in distilled water. The soil samples were allowed for 3 minutes to absorb the water from the filter paper. After the 3 minutes have passed, distilled water was added up to a certain level above the aggregates. The samples prepared using this method were rested for 10 minutes, after that were rotated in the table plan three times without being lifted from the table in the clockwise sense. Next step was to gentle drain the water surplus, after which each sample was extracted on a white sheet of paper and the result is compared with the models from the auxiliary board.

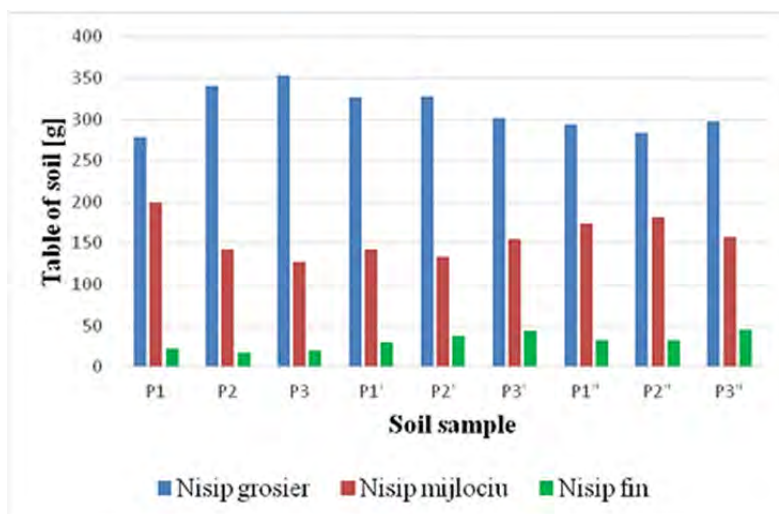
**Fig. 5.** Structural fractions of the analyzed soil

The results of the texture analysis show the fact that coarse sand fraction are found predominantly, followed by middle sand and a small proportion of fine sand (figure 5).

In order to determine the texture of the soil, were weighted 500 g of soil/sample using the analytic scale. The weighted soil was introduced in the RETSCH bolter equipment, which has 11 bolters with the diameter of: 0,8; 0,6; 0,44; 0,32; 0,20; 0,16; 0,15; 0,071; 0,063; 0,056; 0,040 [mm], and the soil which remained of each bolter was weighted. Based on the soil mass remained on each bolter were determined the structural mass fractions found in the studied soil.

According with the bibliography, correlated with the textural specialty results, the soil from the analyzed area has a relative high permeability being formed mainly from coarse sand and middle sand.
